The Safety and Enforcement Division (“SED”) of the California Public Utilities Commission conducted a G.O. 112, Operation and Maintenance Inspection of Southern California Gas Company's (“SoCalGas”) Honor Rancho Storage from May 20, 2019 to May 23, 2019. SED conducted field inspections of pipeline facilities in the Honor Rancho Storage within the Inspection Unit. SED’s staff also reviewed the Operator Qualification program, which included field observation of randomly selected individuals performing covered tasks.

**2019 SoCalGas Honor Rancho Storage  
5/20/2019 to 5/23/2019**

**Notice of Probable Violations**

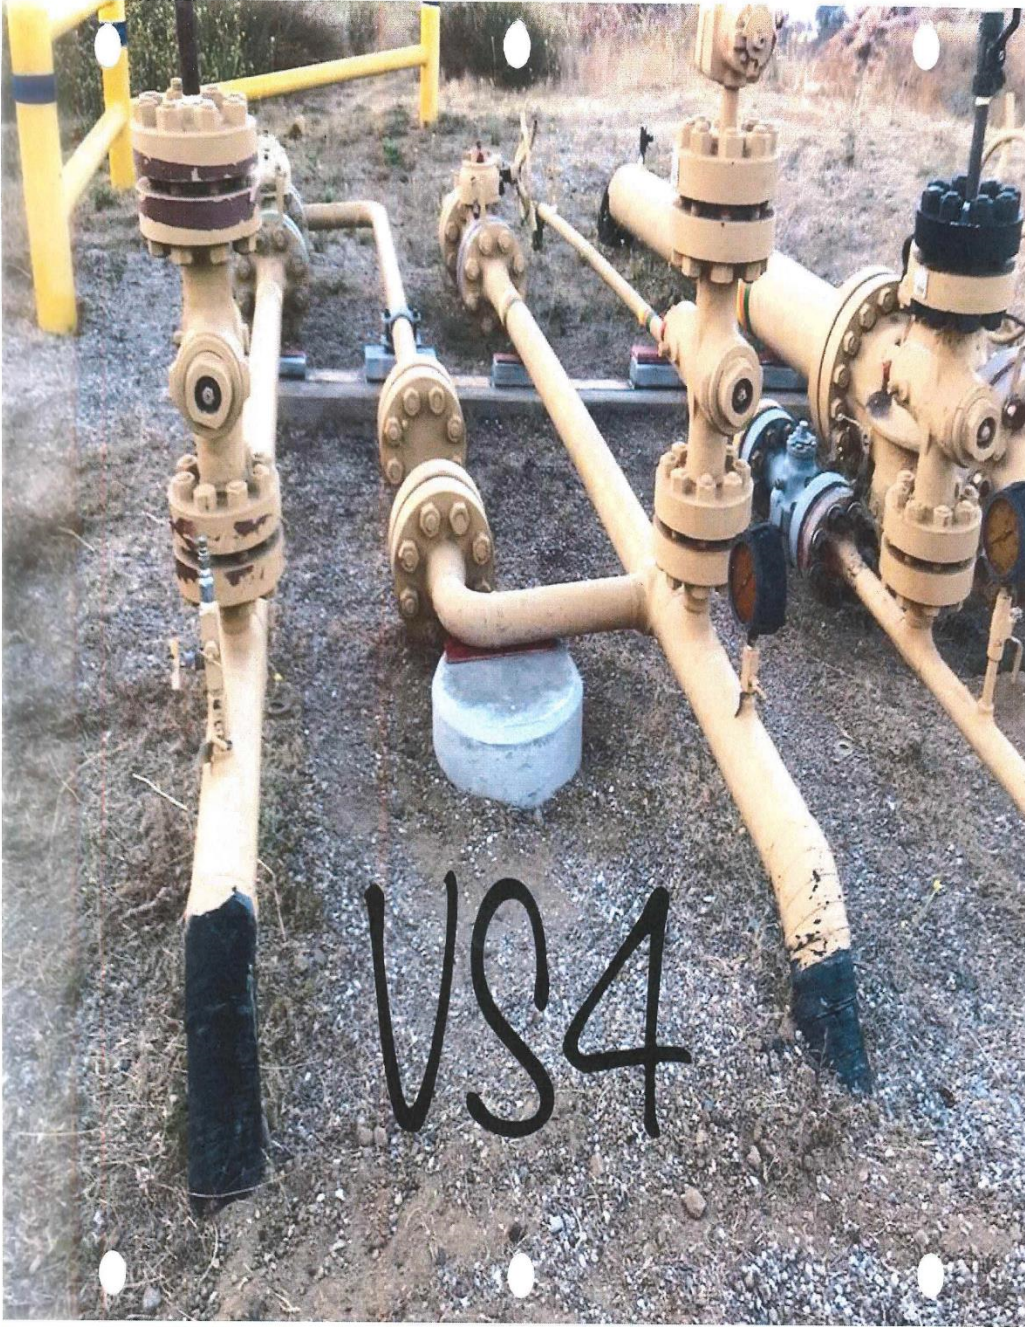
1. During the field inspection, SED staff observed that the aboveground pipelines had a missing /damaged pipe support that may cause undue strain and excessive vibration at the following locations:
  1. Valve Station 4 - HR-NG-VS4-003 – Missing support (dead end flange)
  2. Valve Station 1- Missing support for the flange
  3. Withdrawal dead end flange outside the compressor building had a missing pipeline support

1. Maximo work order # 7057358 (completed 6/24/19) was issued to add additional support at Valve Station # 4.

See picture below:
